Manhole Inspection Summary

Manhole # S07CC2014MH

Insp Date: **8/9/06 7:45 AM**

Location Address: **6002 RUSK AVE**

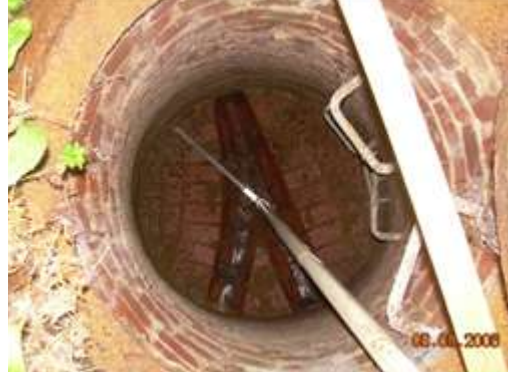
Top View

Bench debris. Channel debris.

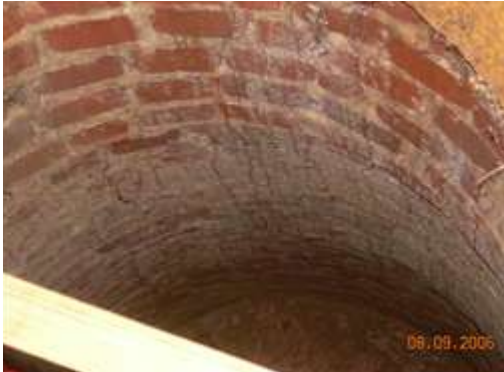
Defect

Adjustment, Corbel, and Barrel infiltration.

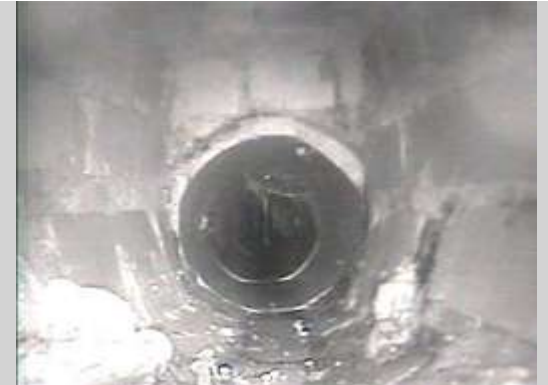
8 in. Circular Gravity Sewer Pipe Out @ 12 O'Clock

Infiltration: **Evidence** Pipe Seal Cond: **Unknown**

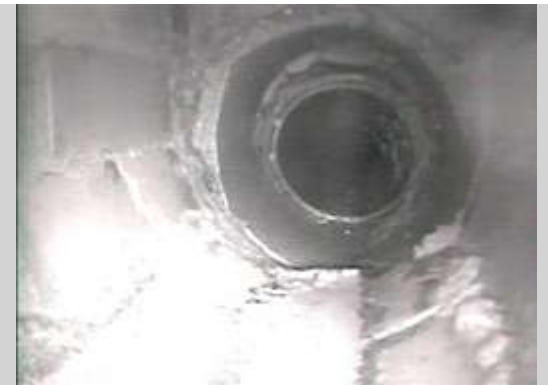
8 in. Circular Gravity Sewer Pipe In @ 6 O'Clock

Infiltration: **Evidence** Pipe Seal Cond: **Unknown**

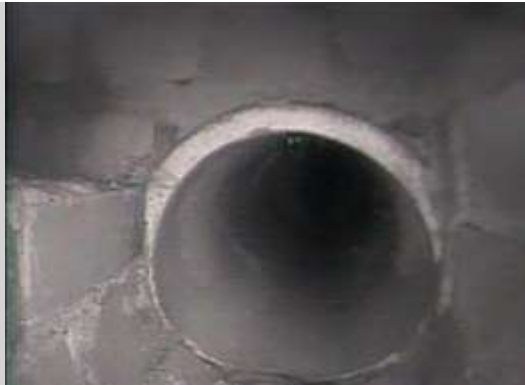
Pipe In @ 7 O'Clock

Infiltration: **Evidence**
